A | C | R CASE STUDY

Water Damaged Gym Floor: *Advanced Strategies to Minimize Loss-of-Use.*

This case study profiles a partial floor recovery in which plumbing failure released water down the gymnasium wall and across the center of one half of the gym floor. The damage was highly concentrated and created a significant buckle as well as the typical individual board cupping.

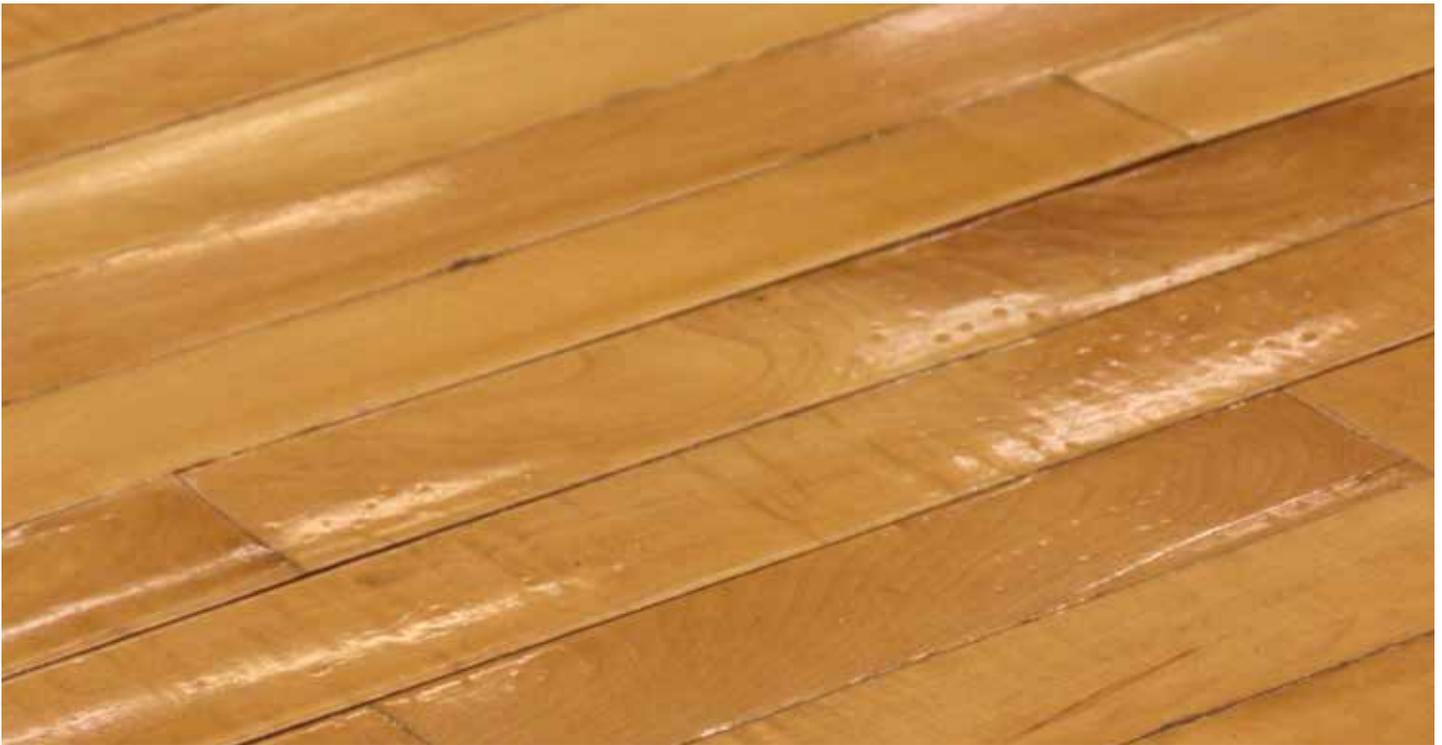
The recent improvements to ACR's restorative drying have reduced the drying time to just days. **This half floor was completed in just 5 days.**

ACR has introduced an advanced technique using precise temperature control to increase the capability to remove moisture using our already efficient in-place custom drying systems. Prior to the addition of temperature control, most affected floors were expected to be dried in several weeks, still far better than the months required to tear-out and replace.

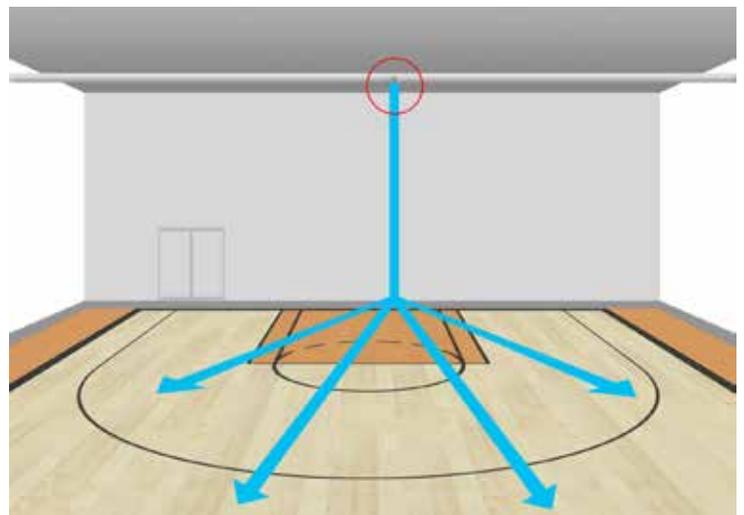
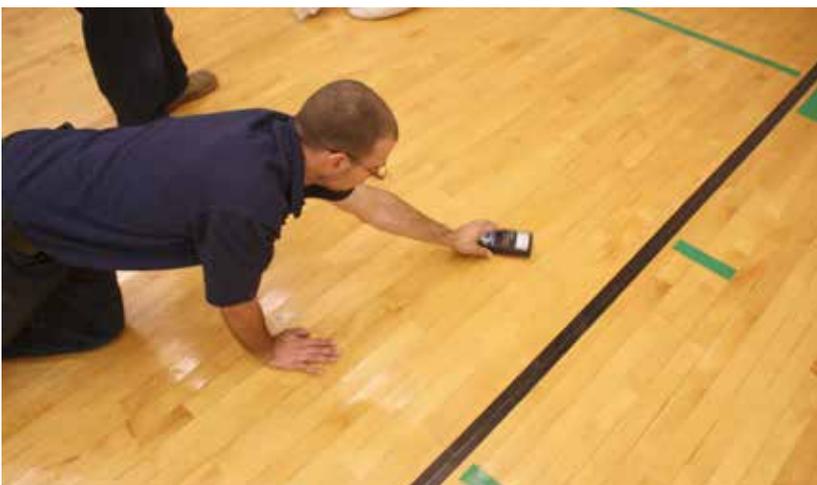
The Path of Damage

In this case, a plumbing related failure released water down the wall, flowing under the center of the affected half of the gym. This water loss was more highly concentrated and directional, causing a higher range of damage into a smaller area.

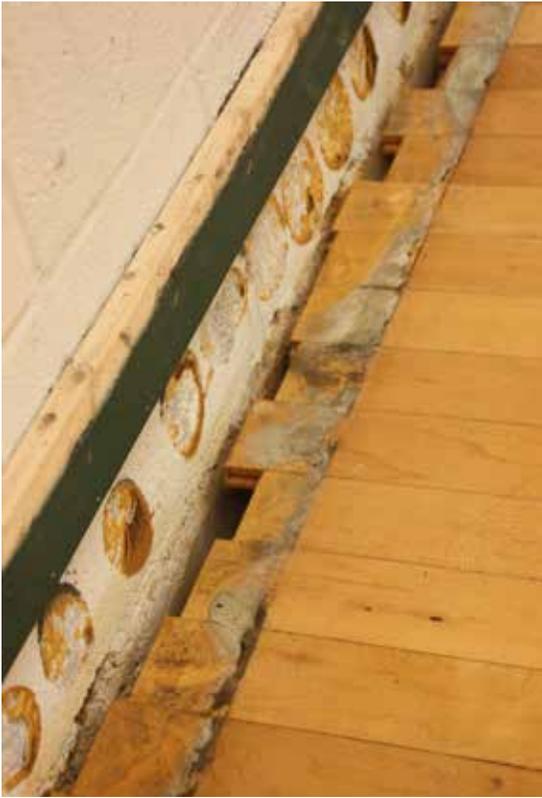
Expert Diagnosis

Moisture meter readings are taken across the entire surface to determine the nature of the water loss. It is very important that readings are interpreted properly, based on the environment and physical properties of the materials.

The gym floor is itself a system, and readings must include the complex underlayment and substrate, which also must be dried.

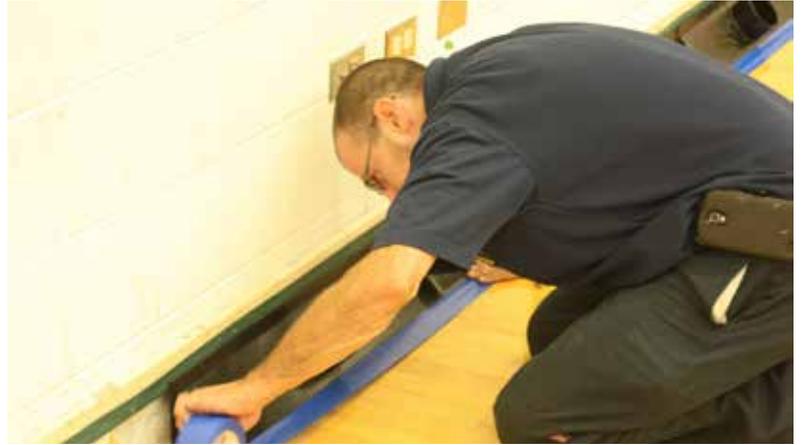
Revealing

As baseboard is removed, it is easier to see that the flooring is only the topmost component of the entire flooring system including the subfloor structure and base substrate, most often concrete. It is essential to understand the system as a whole in order to successfully dry a gym floor in-place.

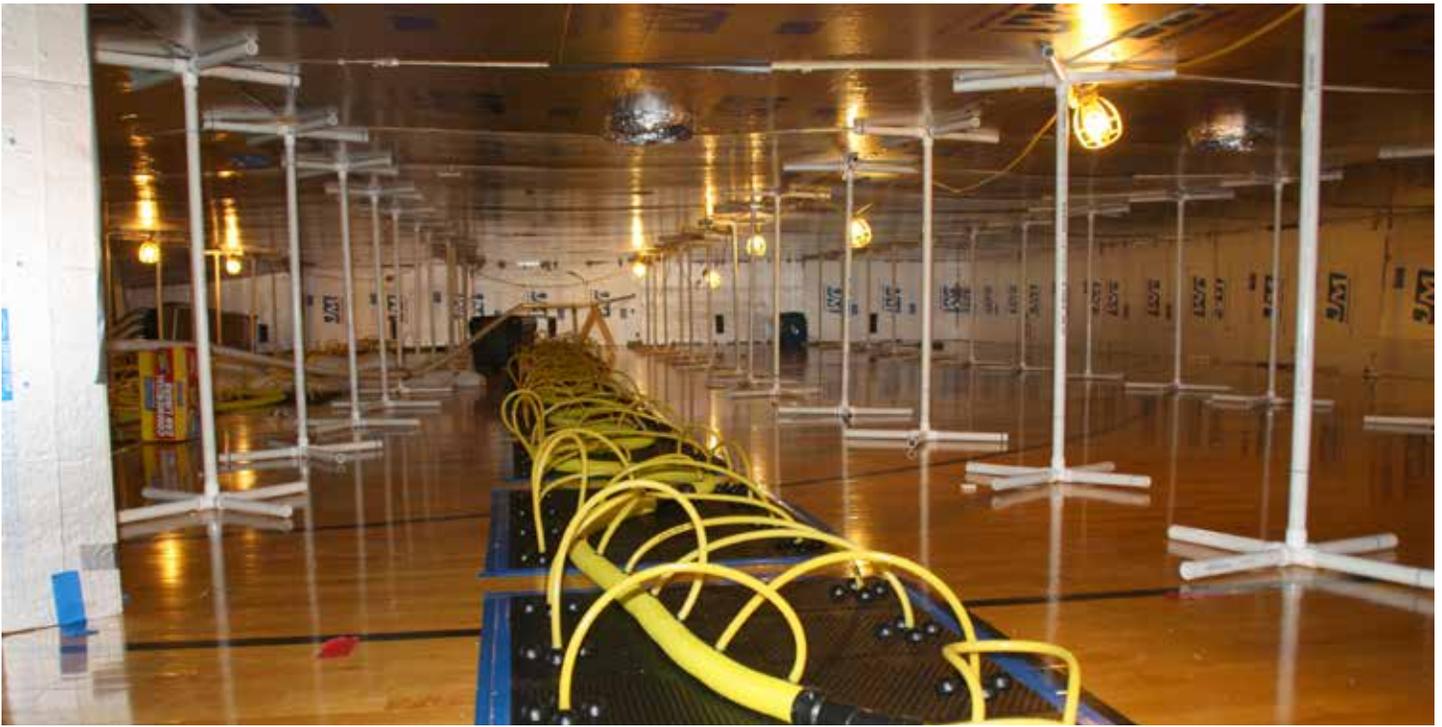
Up and Running

With the custom drying system set up and initiated, the push-pull air movement enhanced by temperature control begins to extract moisture from all levels of the flooring system simultaneously.

Because of the efficiency of this system, careful monitoring is required throughout the drying process.
